Technical Note

Minor Cuts / Crushing of Boise I-Joist Flanges

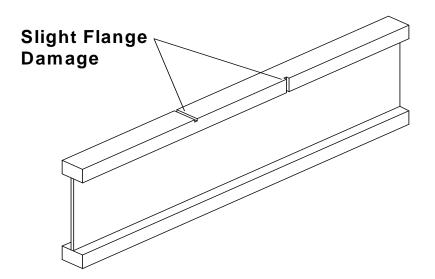
Saw cuts are unfortunately a common occurrence in wood construction. Cutting or drilling of BCI/AJS joist flanges is not allowed for any condition except for birdsmouth cuts for roof joists. However, relatively small cuts or crushing (e.g.: from being banded for shipment) in the flanges does not significantly reduce the allowable design values of Boise I-joists. Thus, the following table shall be referenced for allowable depth cuts, holes or crushing for corresponding BCI/AJS series joists. If the intrusion is less than or equal to depth shown, no repair or reinforcement is required. As shown below, the table refers to slight damage both on the top and into the side of the flanges.

Boise I-Joist Series	Max. Allowed Depth
BCI 40, 450, 5000	1/8"
AJS 140, 150, 20; BCI 60, 600, 6000, 6500	3/16"
AJS 24, 25, 30; BCI 90	1/4"

Maximum number of cuts per joist: 2 Minimum distance between cuts: 36"

If a cut or crushing exceeds the limits shown above, an engineering analysis is required.

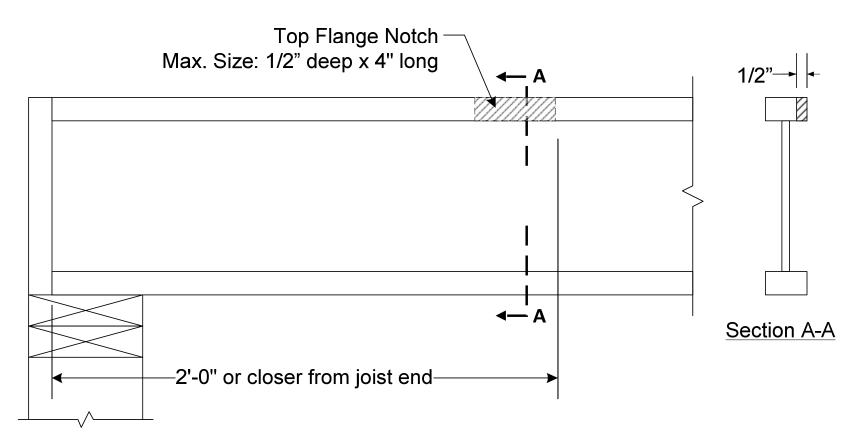
BCI[®] & AJS[®] Joist – 1/2" Deep Notch Top Flange Near Bearing

No reinforcement or repair required for the notched flange condition shown above. Allowance valid for uniformly loaded joists only.
